A VIBRANT VICTORIA HARBOUR

2/2009

An Evaluation of 48 Leisure and Cultural Sites

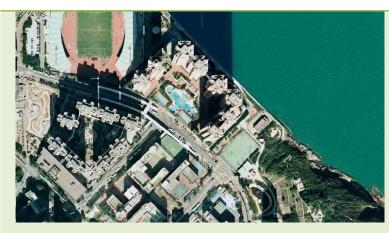
Siu Sai Wan Promenade

Upper seating area in front of mall and area below it not connected.

The lower walkway has no benches. Many benches along the upper walkway were in use. Add more benches to the lower promenade.

Add stairs to for better access to water.

Replace waterfront fence with one that does not obstruct view. • Move concrete storage box to another site and replace with a garden. • Replace fence around football pitch with one matching tall green ones at the corner of the field. Plant trees and add greenery around the pitch for shade. • Some planted areas are in need of maintenance. Add more greenery and flowers to the gardens.

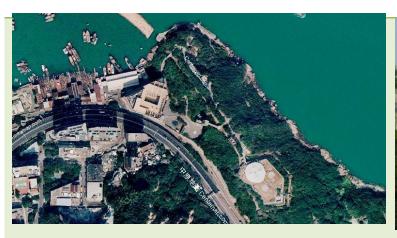
Museum of Coastal Defense

Lacks permanent toilets at water level. Add toilets. • Add dual-language menu on top of cafe's counter, for easier communication.

Continue the promenade from Heng Fa Chuen Playground along the water to the Museum and continue towards Aldrich Bay Promenade. • Add entrance booth to the waterfront path of the museum.

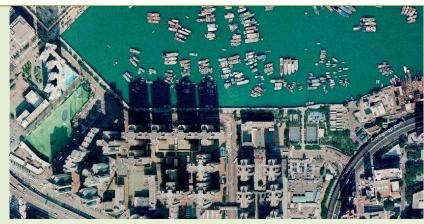
Aldrich Bay Promenade

Tiled area is covered by potted plants. Replace area with food kiosk or game tables. • Add distance markings along promenade for joggers, runners, walkers. Such markings are used in Belcher Bay Park.

Add gates to landing steps. •Add signage towards Sai Wan Ho Harbour Park. • Add signage and information for transport to Lei Yue Mun and the outlaying islands.

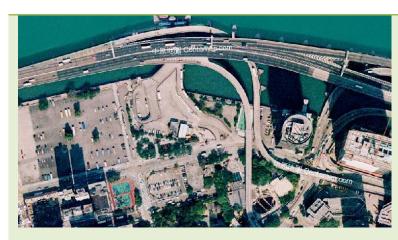
North Point Ferry Concourse Promenade

Basketball court in use during visits. Technically a different LCSD site, however sites are connected. Adds activity to North Point Ferry Concourse Promenade.

Large open space at entrance of the site. Allow ball games in the open space or cycling for children. Place a playground within area. Few restaurants or food kiosks within the surrounding area. Add vending or food kiosk.

Benches along the promenade had cages on the back. Keeps seated visitors safe from flyaway balls and other sports. Fence as a barrier to the road. Replace fence with a noise barrier wall and plant trees to make it more aesthetically pleasing.

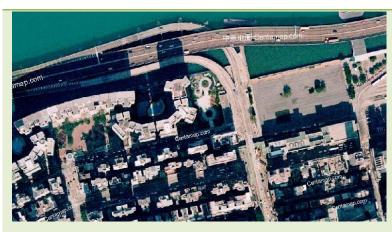
Tong Shui Road Garden

Black fence obstructs access to water. Replace on east side of garden with a noise barrier again the Island Eastern Corridor. Remove from west side of garden. • Remove wall adjacent to Provident Garden and continue the promenade to connect. • Move playground to east side of garden and extend its size.

Benches near cement wall are not shaded and some are broken. Repair broken benches and plant trees for shade.

Add color to the site by painting cement wall. Paint a harbour theme mural to match playground. • Cement block on east side of playground. Remove and build large playground above this area.

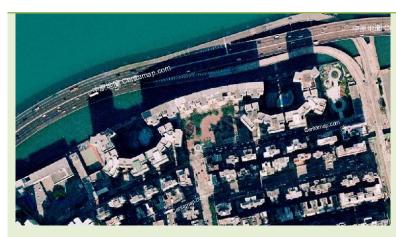
Provident Garden

Plants block gate that leads to tunnel and promenade. Remove barriers to the entrance. • Remove the wall adjacent to Tong Shui Road Garden and continue the promenade. • Move playground to east side of garden and extend its size.

Island Eastern Corridor obstructs harbour view. Build underpass extending from promenade to highway and connecting to nearby playground.

Tunnels under residential buildings lead to waterfront LCSD promenade. Add lighting in tunnel and paint concrete walls. • Add lighting to promenade and paintings, mural, or mosaic to concrete wall.

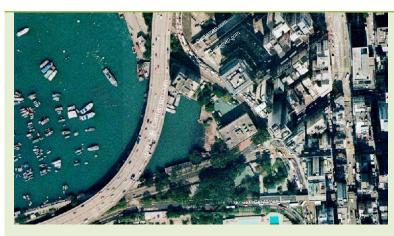
Whitfield Road Rest Garden

The area adjacent to the park appears unused. Expand the park and extend the promenade.

Park contains few benches. Add more benches. • No food or beverage nearby. Add dispenser machines.

Wood fences surrounding the gardens block the view of the plants. Remove them. • Chipped paint on gazebo roof. Repaint gazebo.

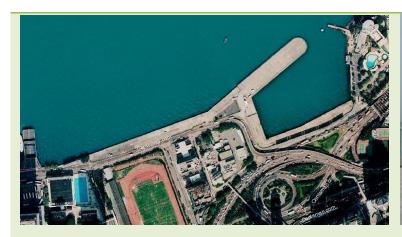
Wan Chai Waterfront Promenade

Plant trees along outer perimeter of park to block noise, add shaded seating. • Fence along waterfront does not appear sturdy—signs say "do not lean." Replace fence with a see-through, glass barrier.
•Remove temporary office and utilize space for dispenser machines and permanent bathrooms.

Remove chain-link fence. Plant trees along outside of chain-link fence. Replant flowers on brick. • White fence with barbed wire on the top separates helicopter pad from park. Remove fence.

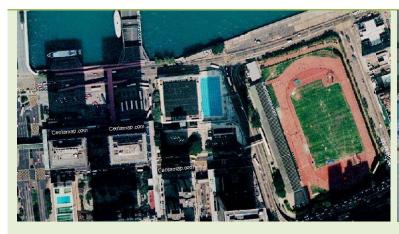
Wan Chai Swimming Pool

Walls between pool and sidewalk are uninviting. Repaint walls, with murals and signs.

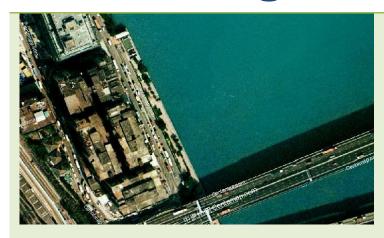
Cheung Fai Road Promenade

Fenced utilities area with barbed wire fence at south end of park. Plant trees and add shrubbery to block view of equipment.

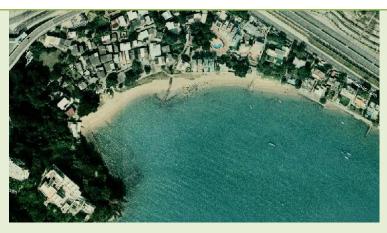
Ting Kau Beach

Add barbeque pits. • There are only two benches at the beach. Add more shaded benches to accommodate more users.

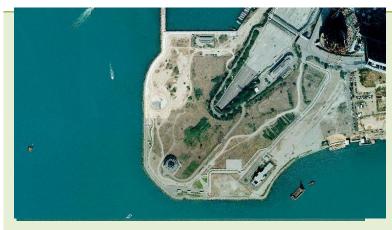
West Kowloon Waterfront Promenade

Many parts of the boardwalk are in need of repair. • The cycle track is unpainted cement. Paint the cycle track. • The Dragon of Lanterns is in need of maintenance in many areas. Replace the sides with painted glass. • Replace dead plants.

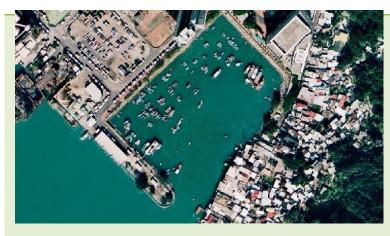
Lei Yue Mun Waterfront Sitting-Out Area

Roof lets sun through, heating up the benches underneath. Replace roof with wood, metal, or a material that provides true shade. • Add tables in front of Sports Centre to allow for people to eat, socialize, and play table games.

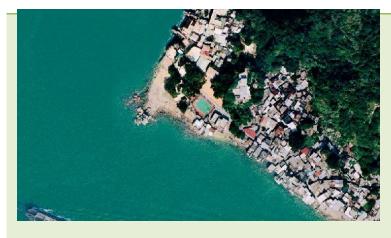
Lei Yue Mun Rest Garden

Add more playground equipment, extend playground boundary. • Remove the broken bottles and litter from the beach.
